# **Limb Re-Growth Survey**

Date: January 2004

## **INTRODUCTION**

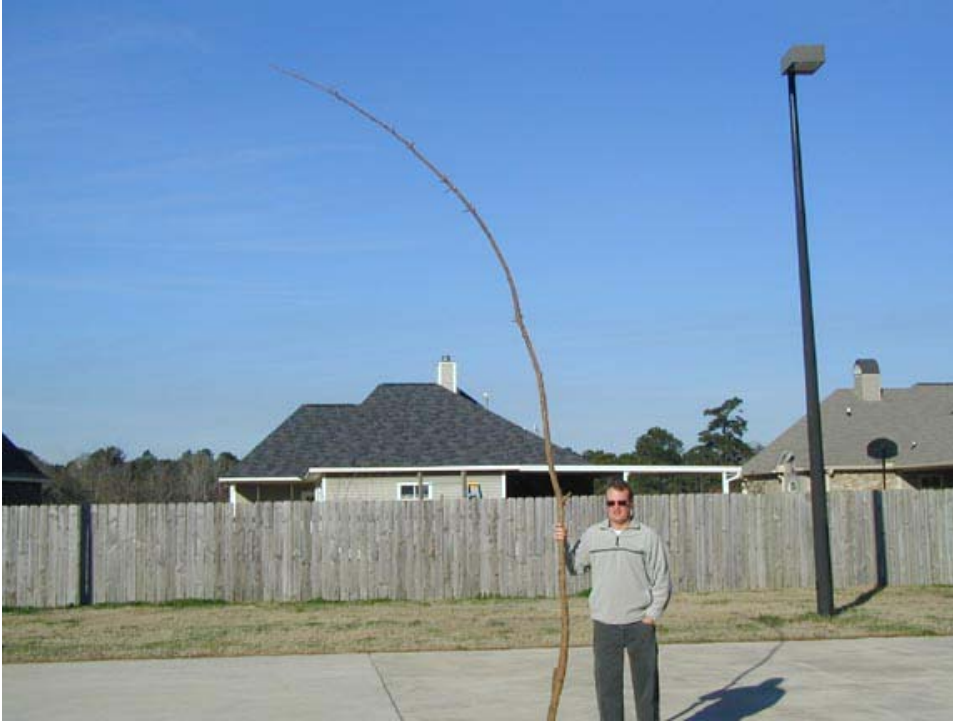
Photo 1. Black Willow 19 Ft., 2 years.

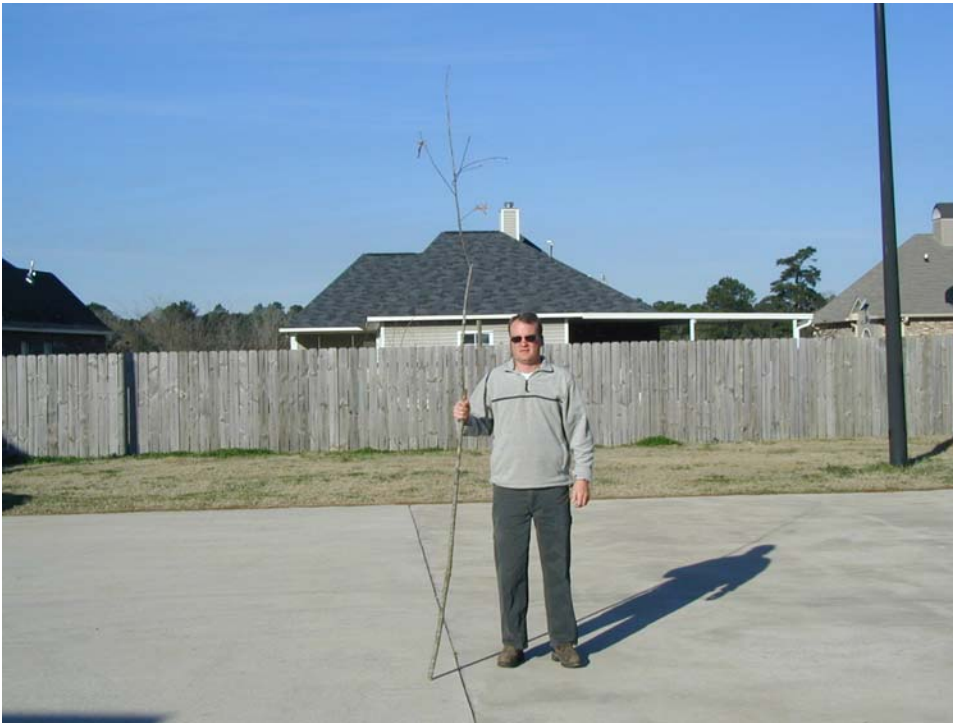
Photo 2. Cherry Bark Oak 10.3 Ft., 4 years.

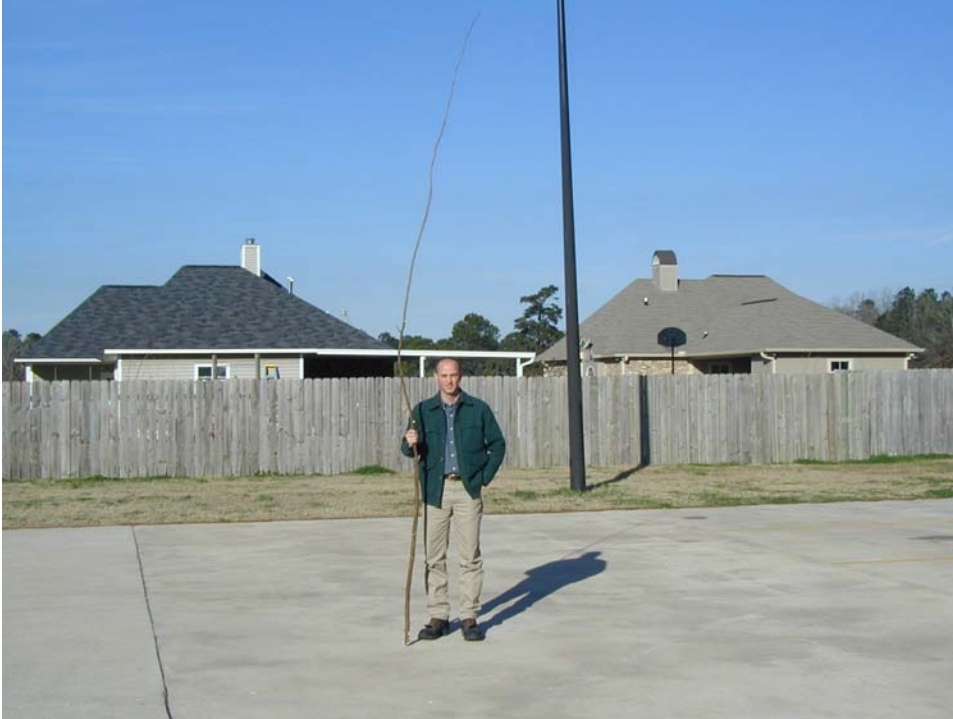
Photo 3. Black Locust 13.9 Ft., 2 years.

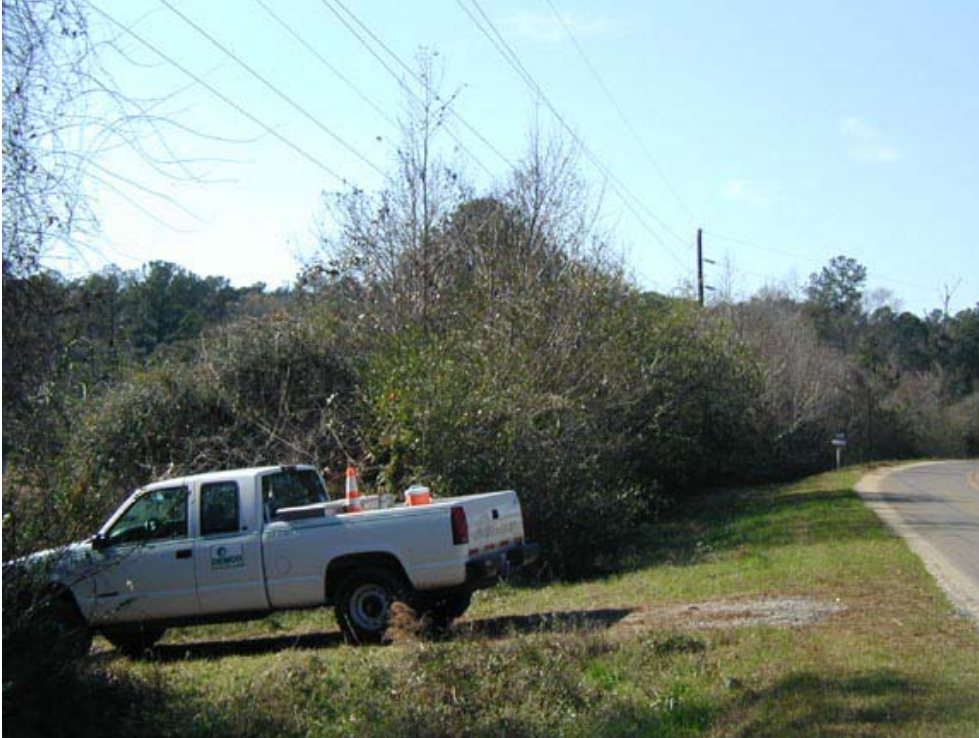
Photo 4. Bad trimming of a fencerow under a line

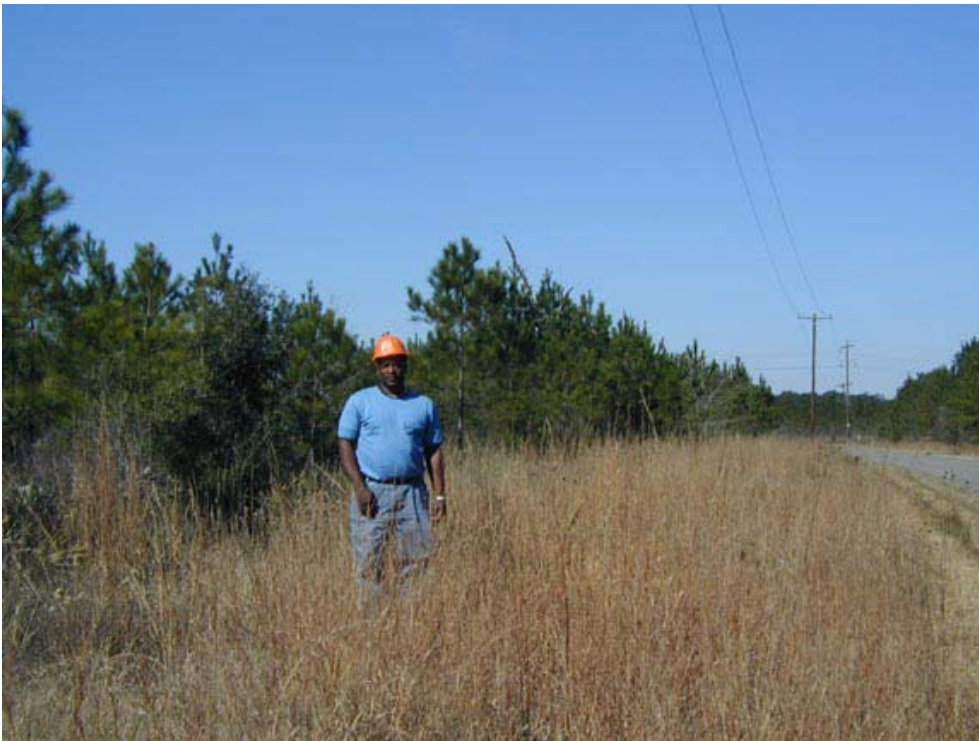
Photo 5. Good trimming under a single-phase line with three herbicide cycles

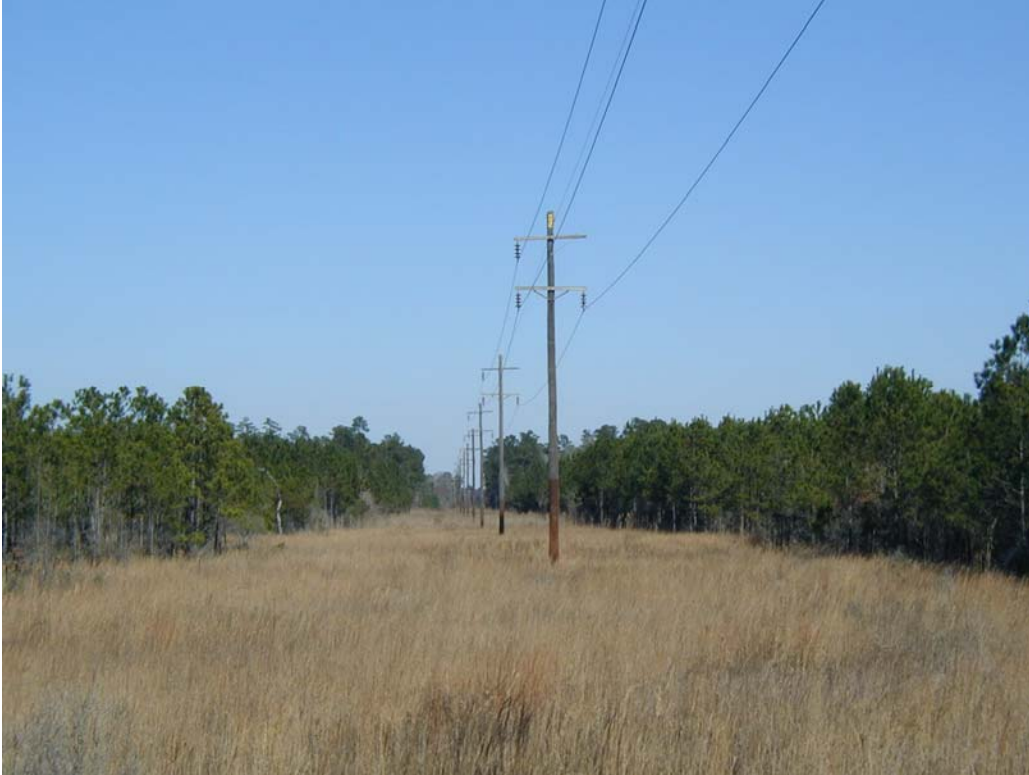
Photo 6. 69 kV right-of-way after three herbicide cycles

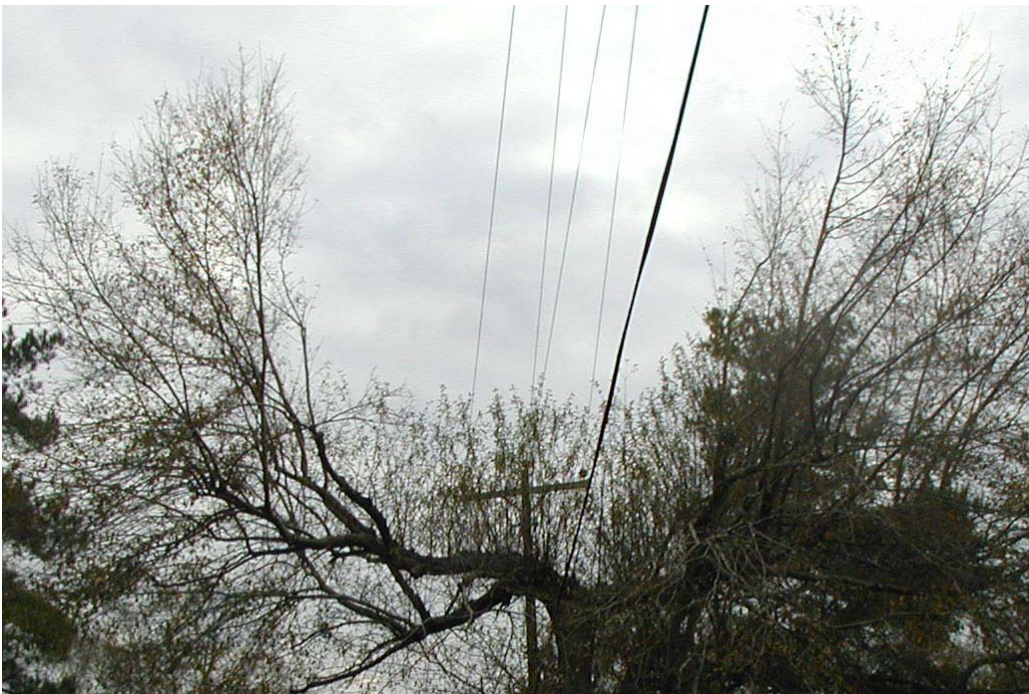
Photo 7. One-Year Re-Growth Due to Re-Trimming Under a Three-Phase Line

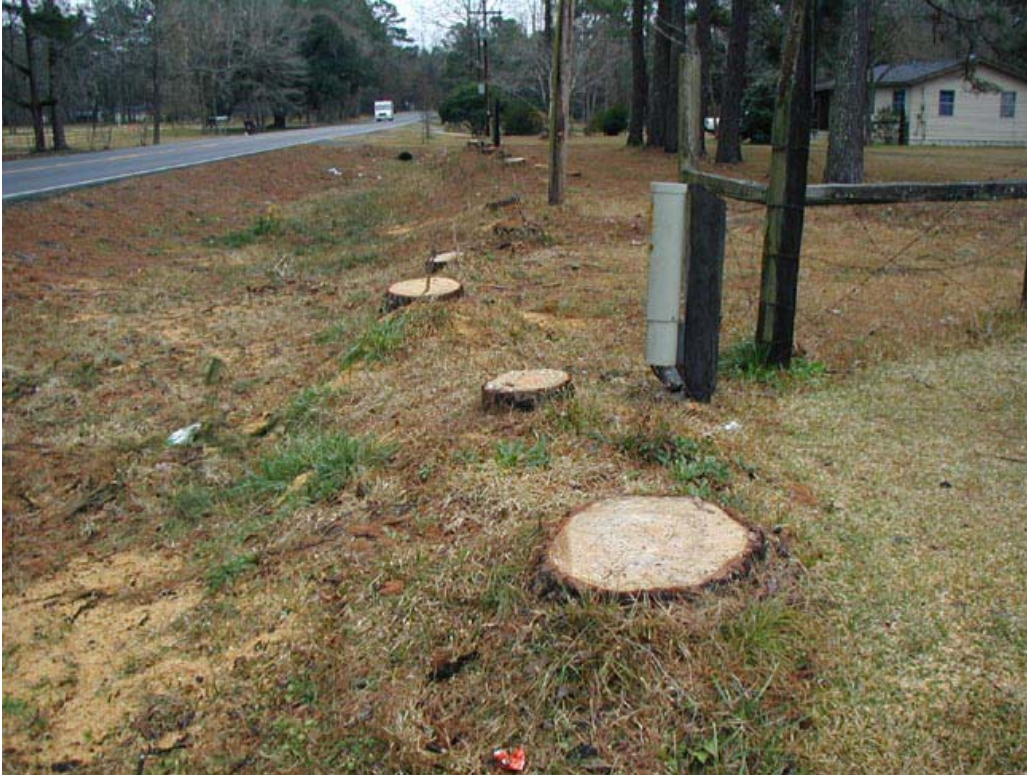
Photo 8. Good Tree Trimming Under a Line
